# TSS-1R Mission Failure Investigation Board

## Final Report

National Aeronautics and Space Administration

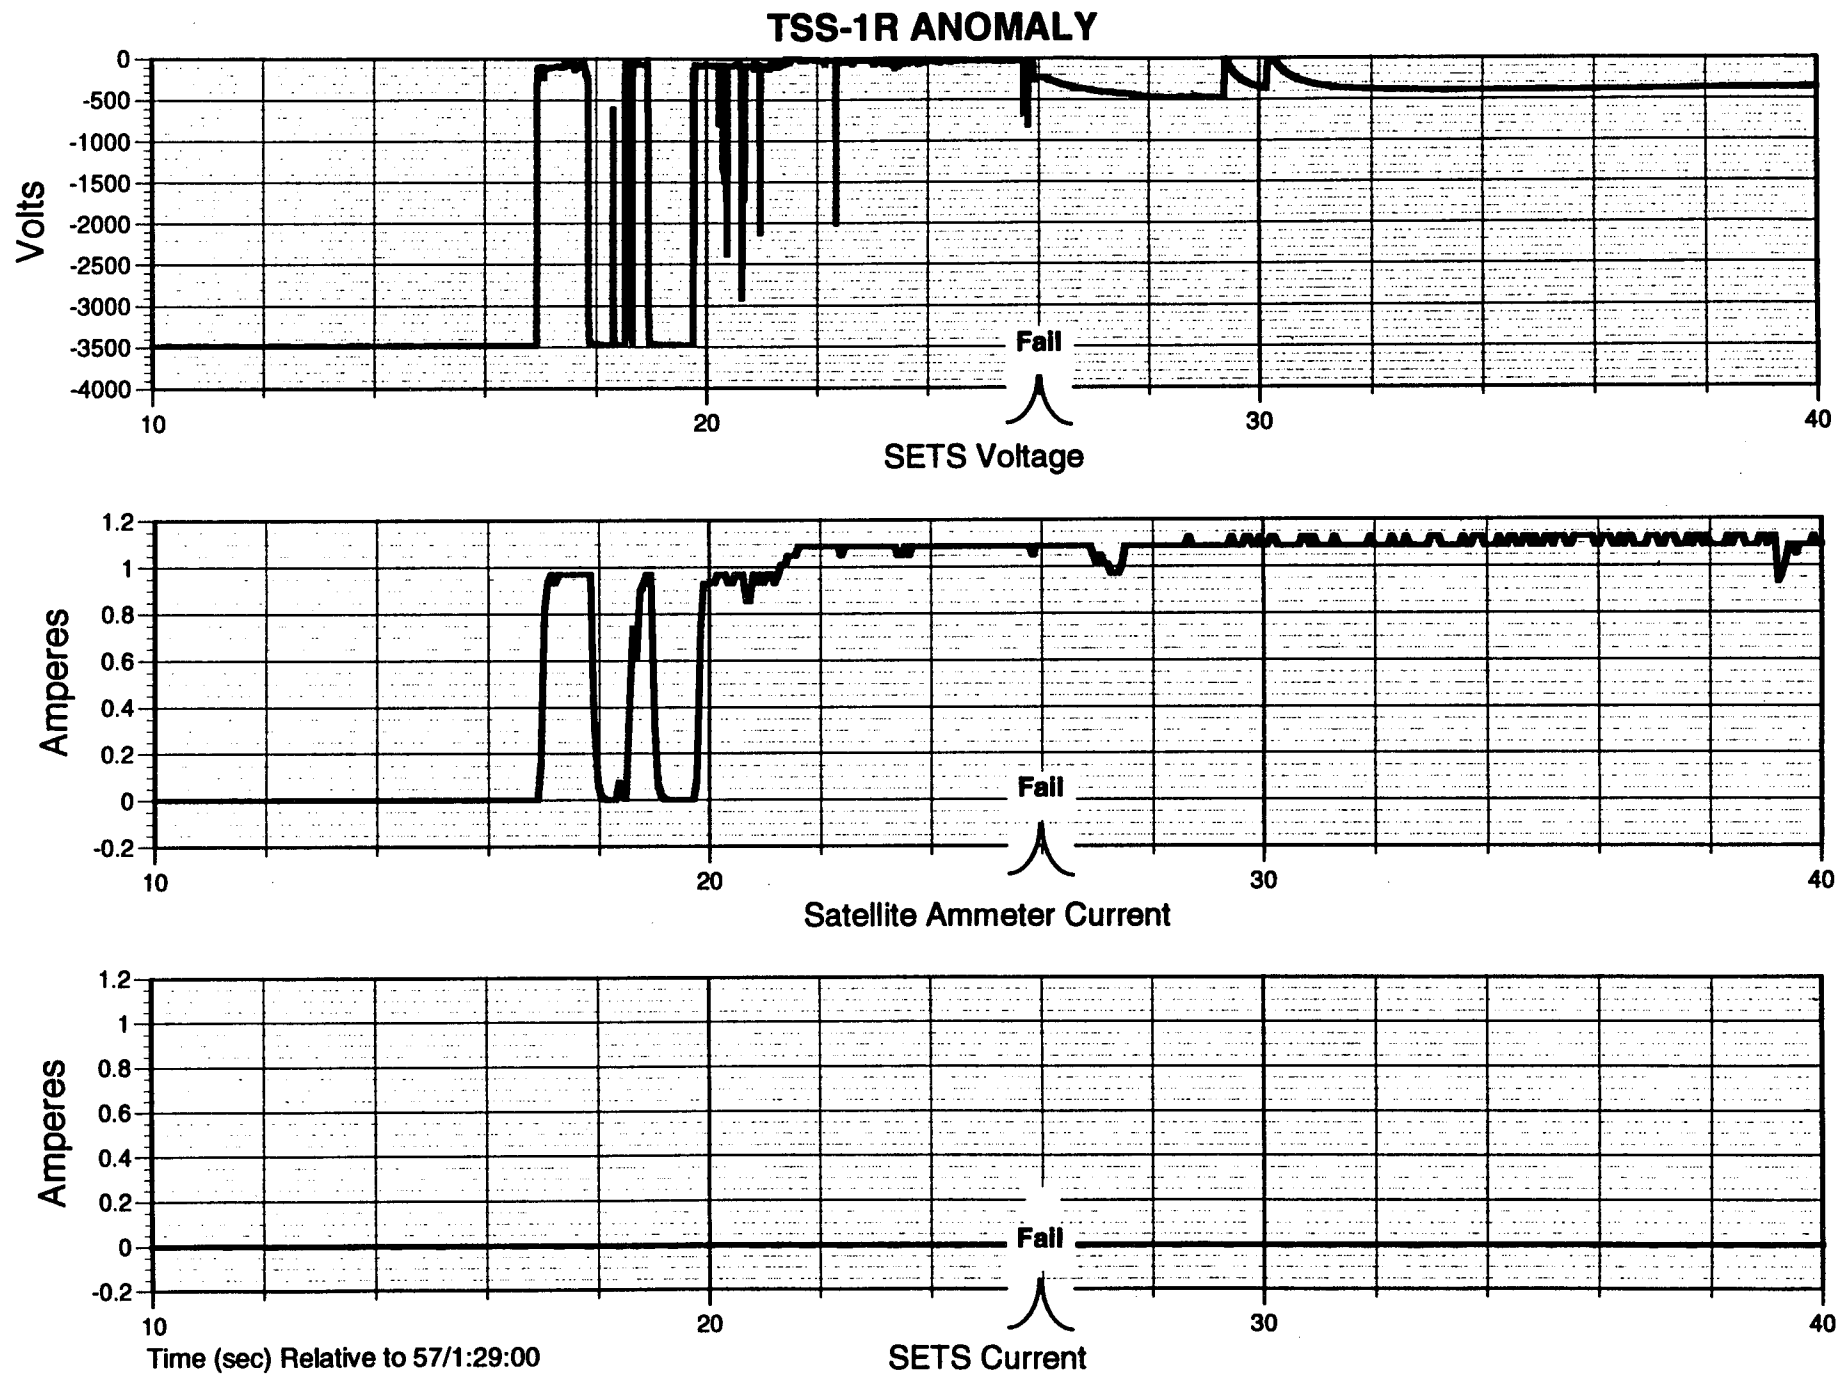
Figure 2.0-2 — History of Key Parameters

This spurious discharge continues intermittently for approximately 9 s before the tether fails. The tether current continued to flow at approximately 1A for another 60 s, indicating a current path directly to the space plasma from the lower end of the tether attached to the satellite.

These measurements provided the data that the Board used to establish that arcing was the primary cause of the ultimate failure of the tether. Based on the measured deployment rate of the tether at this time (1.04 m/s), and the length of the tether retrieved on orbit, it was possible to determine that the arcing started in the LTCM.

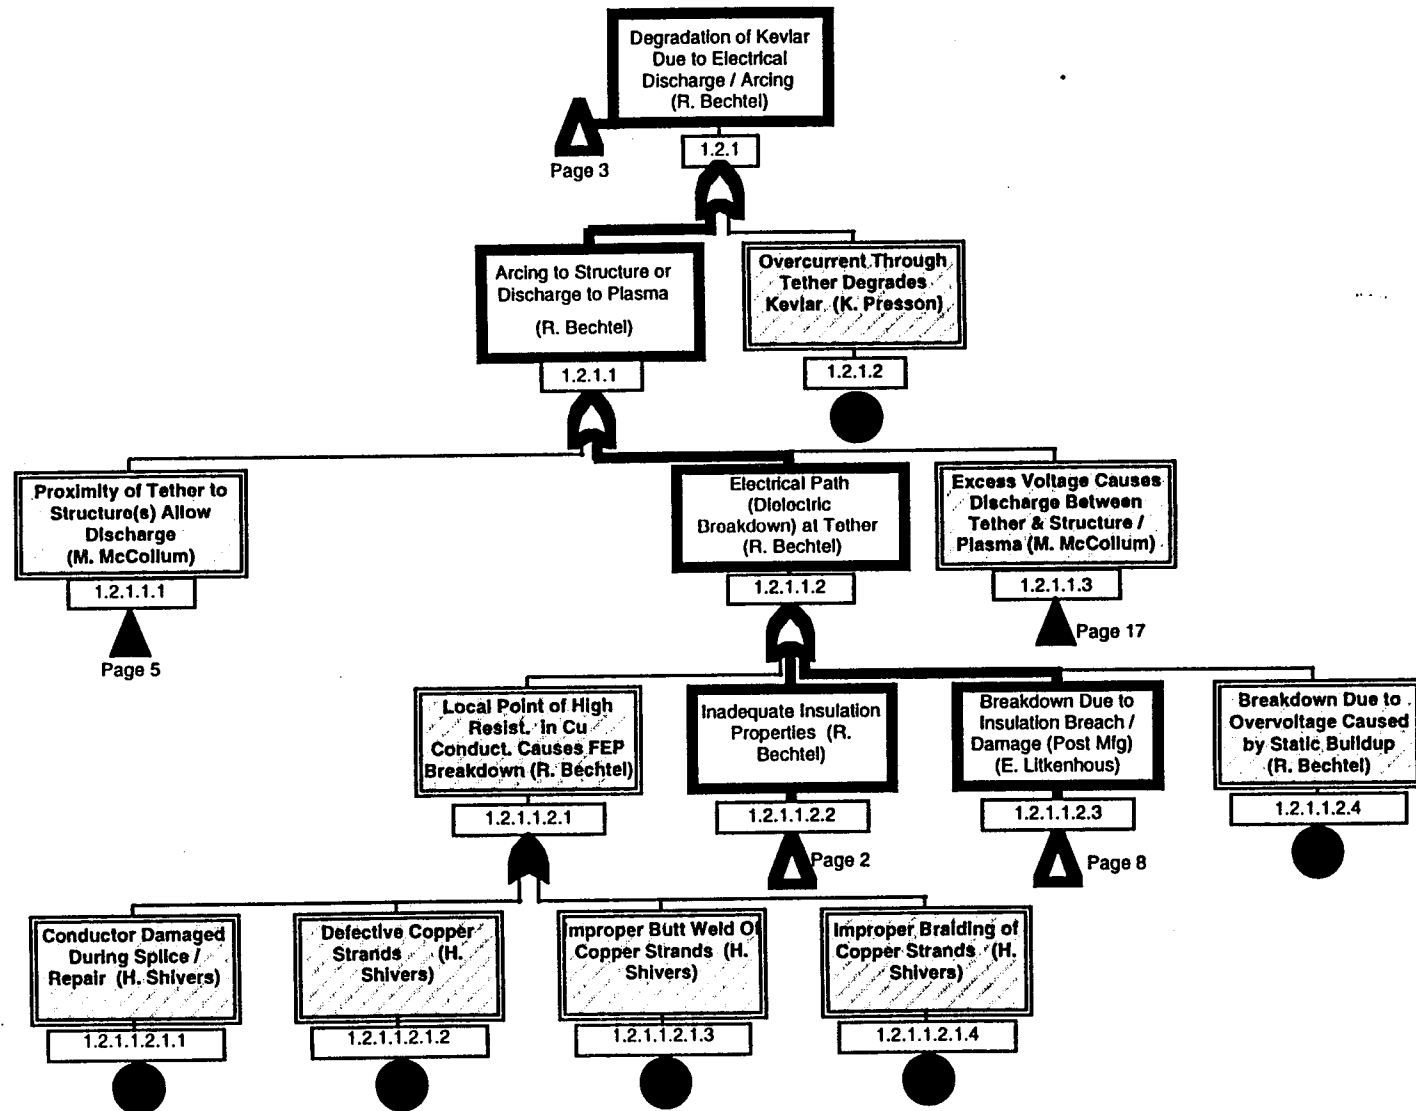
Figure 3.1-4  
3-5

By test, analysis, and examination of flight evidence returned, it was proven that proximity of the tether to structure (specifically, the LTCM) was essential to induce failure, as seen on block 1.2.1.1.1 (figure 3.1-4). In addition, dielectric breakdown of

the tether by discharge or arcing was evident, which implied inadequate insulation, block 1.2.1.1.2.2 (figure 3.1-4); breach of insulation, block 1.2.1.1.2.3 (figure 3.1-4); or breakdown due to overvoltage caused by static charge build up, block 1.2.1.1.2.4 (figure 3.1-4). The evidence then warranted shifting strong effort to the possible causes as noted above.

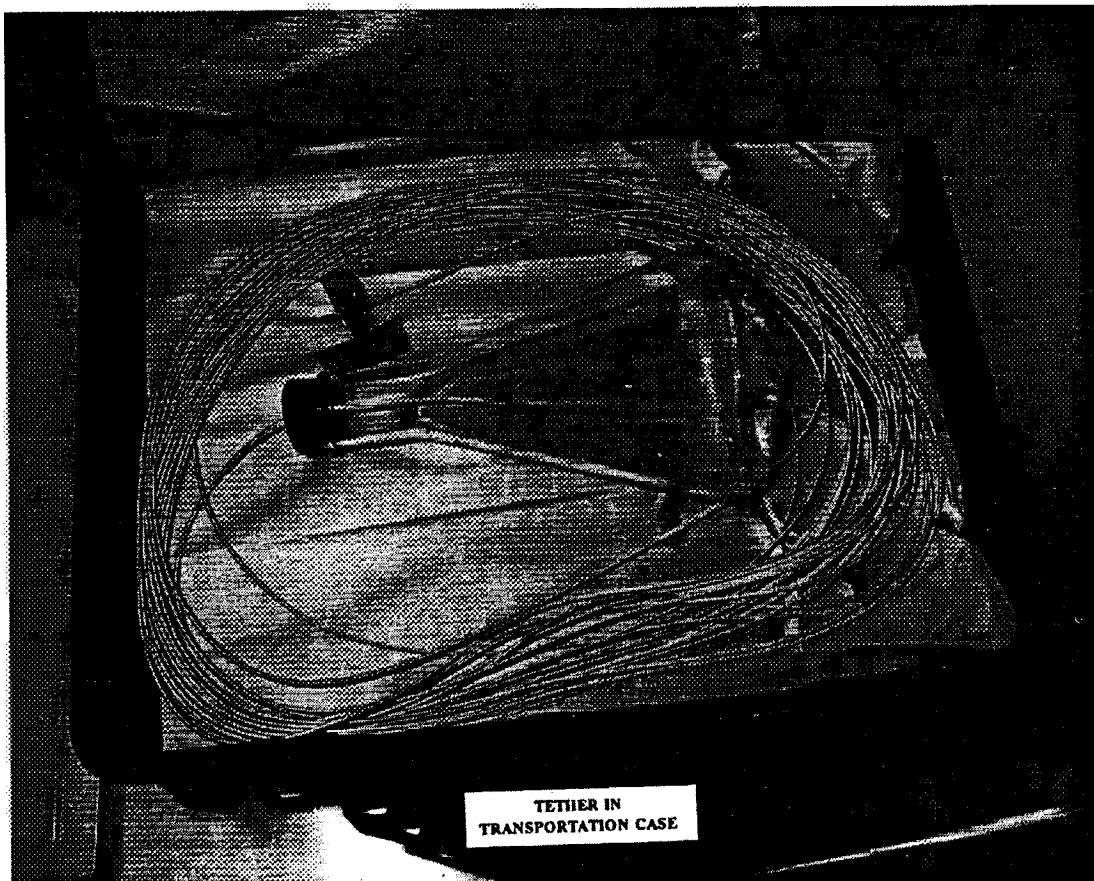
Transporting Failed End of Tether  
Figure 3.2-3

During the deintegration of the TSS-1R after landing at KSC, approximately 27 m of tether containing the separated end was cut from the reel for detailed examination. This particular length was selected to capture the maximum length of tether that could have gone through the deployer mechanisms, and to have an equal reference length immediately adjacent to this section which had not gone through the deployer. The failed end of the tether was placed in a flask for

protection and the 27 m section with flask was packaged as shown in figure 3.2-3 for shipment to the laboratory. Approximately 1,989 m of tether remained on the reel. It was later removed for examination.

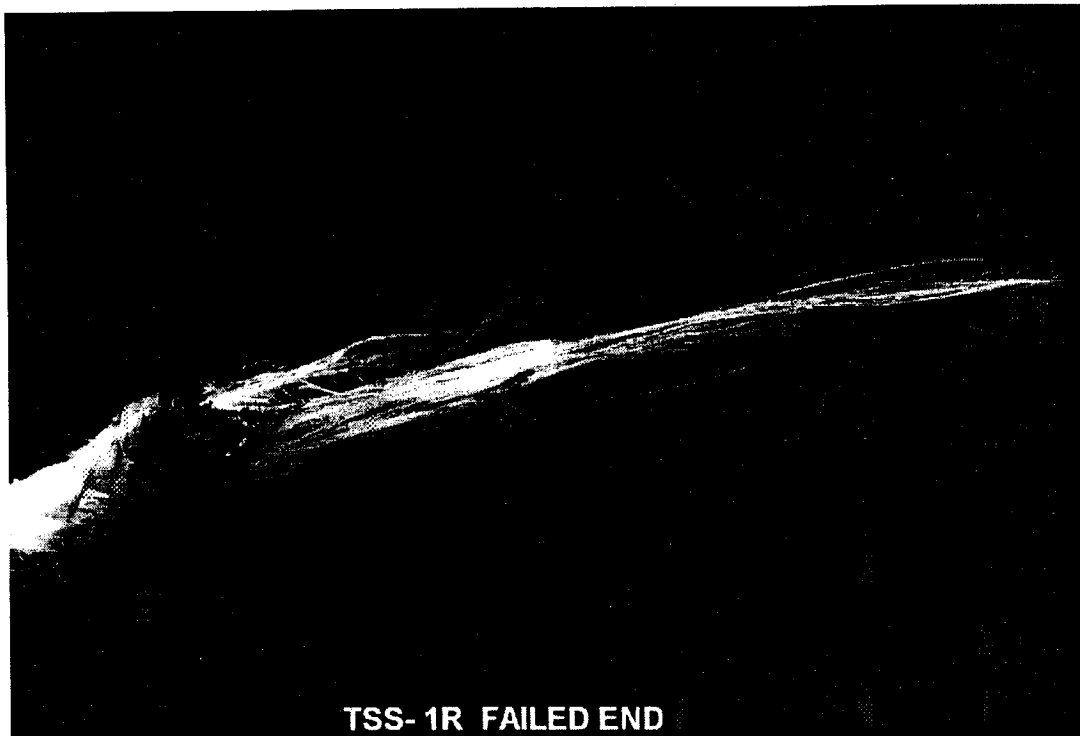
Figure 3.2-4 — Failed End of Flight Tether

shown in figure 3.2-4. Images using x-ray, microphotography, and SEM were taken. These revealed that 2 to 4 of the 10 copper conductors failed in tension and the others melted through. The FEP insulator was completely burned or melted away in the break area. Most of the Kevlar, and inner and outer Nomex were also burned or melted away. Some remaining Kevlar and Nomex fibers, which did not burn, were failed in tension (see figure 3.2-4).

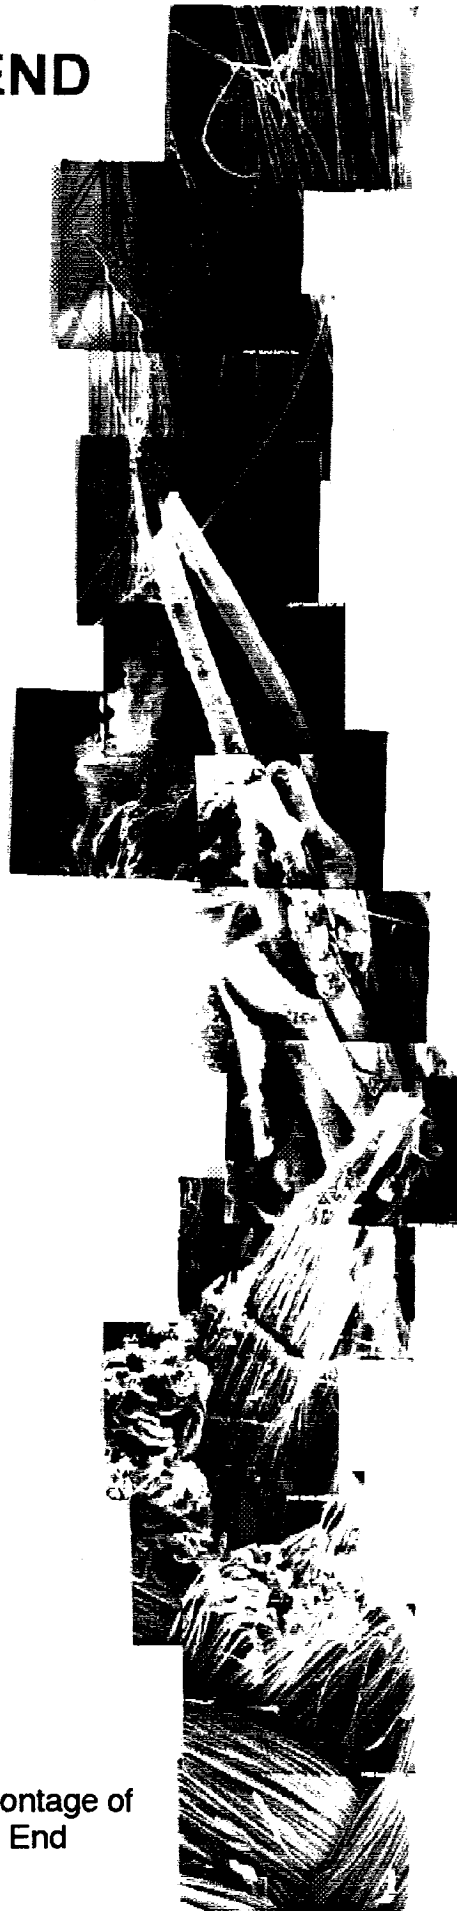
Figure 3.2-5 — SEM Montage of Failed End

SEM images were taken and 3 montages were compiled from these images showing views at 90 degrees rotation. One of these montages is presented in figure 3.2-5. An EDS examination was done around the separated end and several foreign elements were identified in the break area. Figure 3.2-6 is an example of the elemental composition found. The identified foreign elements are: iron, titanium, sodium, calcium, silica, and aluminum. EDS analysis of other areas of the failed end also showed traces of nickel.

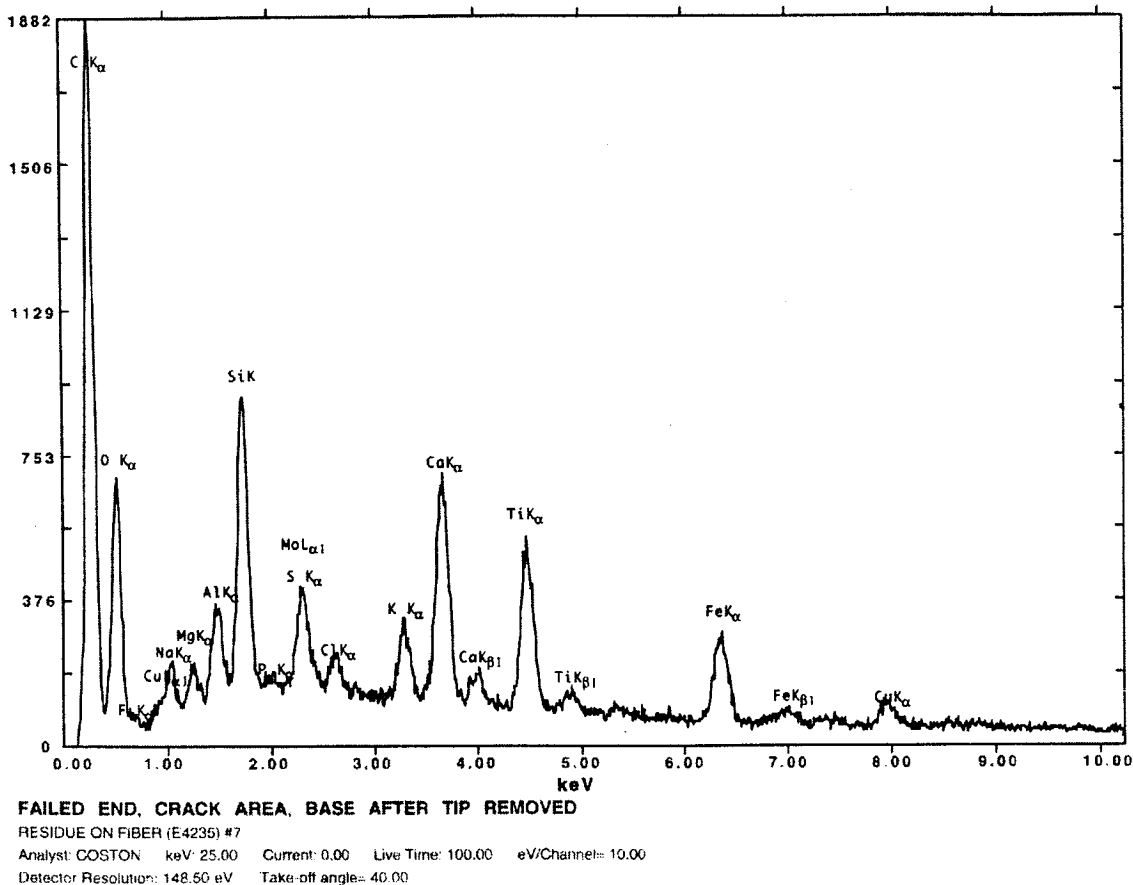
Figure 3.2-6 — Elemental Analysis at Failed End of Tether

Intrusive examination of the failed end consisted of removal of the Nomex and Kevlar jackets such that the FEP insulation and copper wire could be examined just aft of the burned area. As each jacket was removed, that interface was subjected to SEM and EDS analyses.

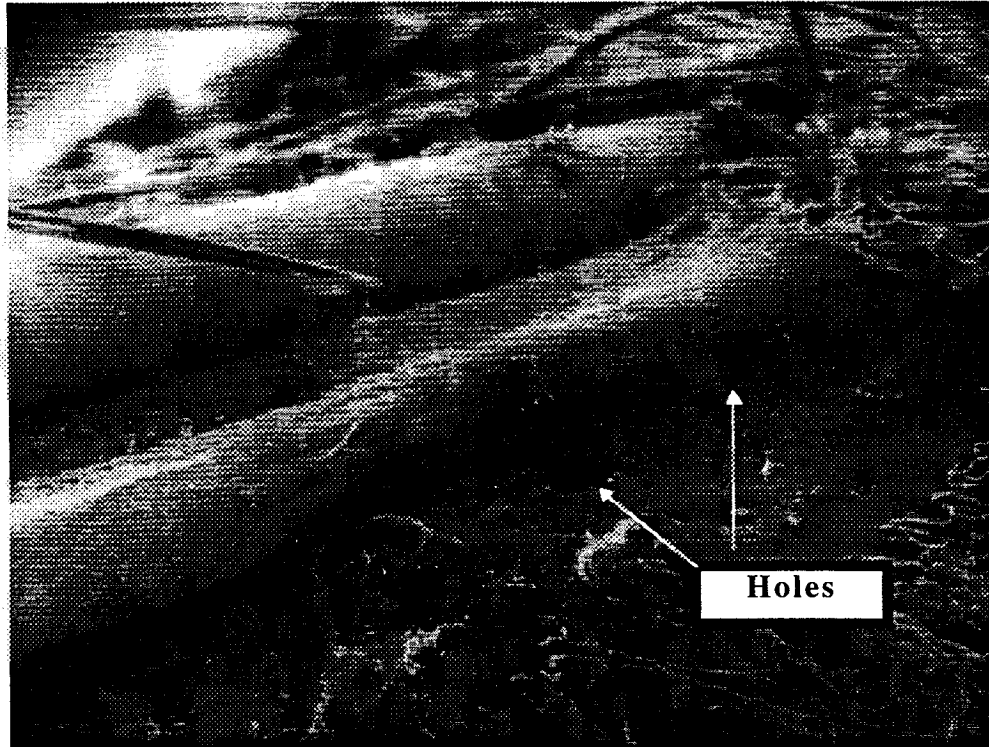
Figure 3.2-7 — FEP DAMAGE IN FAILED AREA

contributed to the arcing, or merely a result of the discharge/burning or heating which occurred in the immediate area.

c) Immediately adjacent to the copper wire melt-area, 8 of the 10 wires had multiple "nicks" across them and the wire with the deepest nick was cut half way through its diameter (approximately 0.075 mm deep). The FEP at these nicks had burned away. A second location of nicked wires was found approximately 2 m away from the failed end. At this location, 7 of the 10 wires were nicked and the deepest penetration on one wire was about 1/3 of the wire diameter. These indentations appear to have been made by a sharp object. The FEP insulator immediately over the nicks show no signs of any damage, indicating that the wires were damaged prior to the FEP application.

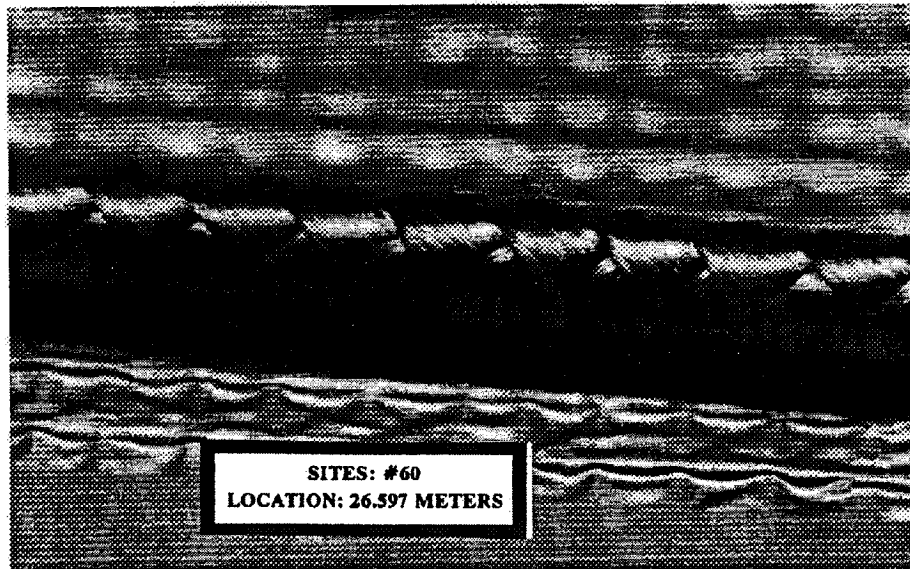
Figure 3.2-10 — Typical Spot

An analysis of the spot locations revealed that all but one of the spots were within a definite linear pattern of finite spacing. Sets of these spots matched up perfectly with the linear distance (circumference) around the 4 pulleys located in the LTCM. The 2 idler pulleys and the tensiometer pulley all have the same circumference of 0.24 m and the encoder pulley has a circumference of 0.50 m. As discussed in section 3.3 each of these pulleys have one pyrolyzed spot on its circumference; therefore the conclusion is that as the tether traveled through the pulleys, each pulley repeatedly deposited some of the carbon on the tether as it rotated. This process continued for approximately 9 m (or 9 s) from the failed/burned tether end. Figure 3.2-9 summarizes the analysis showing the set of spots for each of the 4 pulleys. Figure 3.2-10 is a picture of a typical spot.

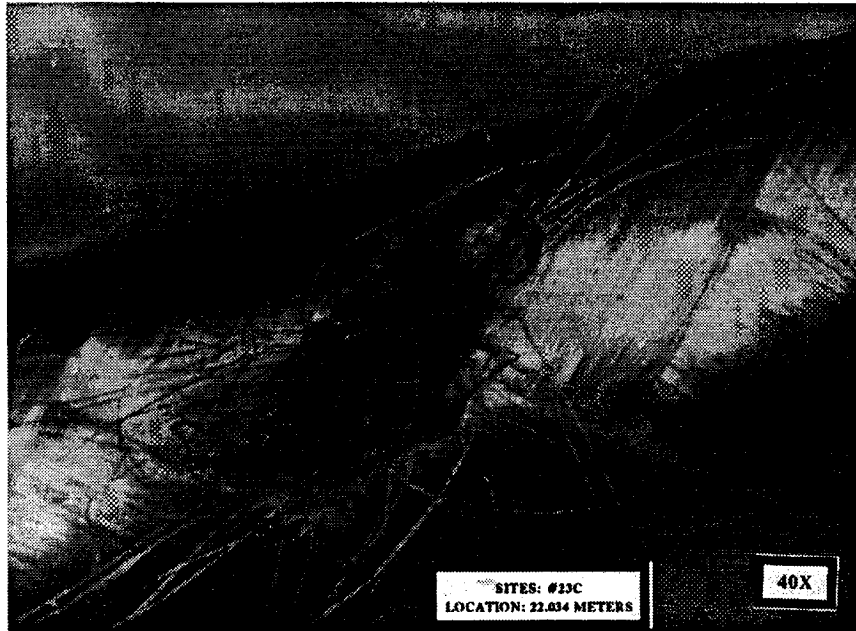
Figure 3.2-11 — Kevlar Fiber Protrusion

b) At three locations on this section of tether, Kevlar fiber was found to be protruding out from under the Nomex tows. The cause of these tufts are unknown and remain unexplained. Figure 3.2-11 shows a typical tuft of Kevlar. The Board did not attribute any part of the failure to these tufts.

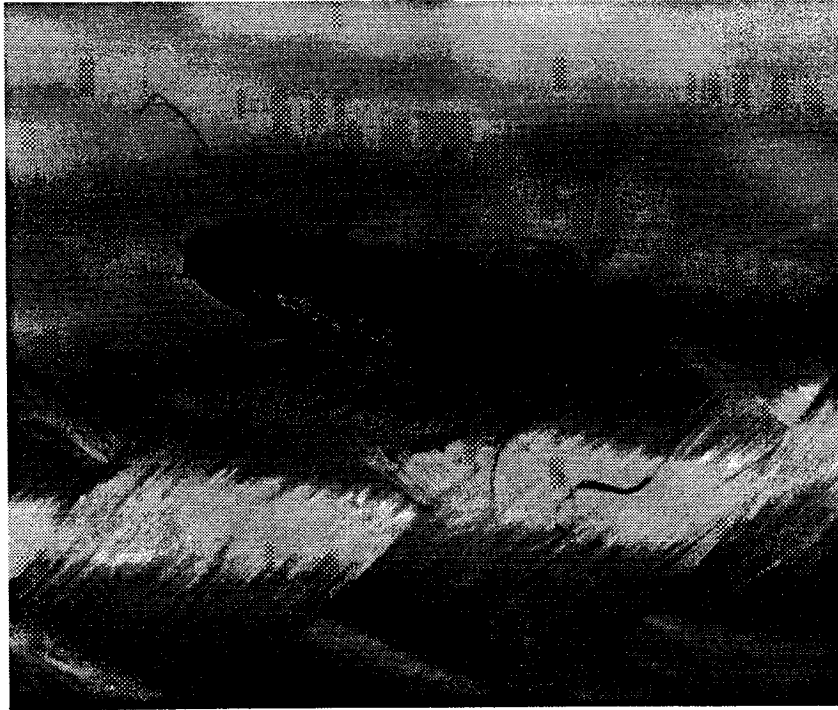
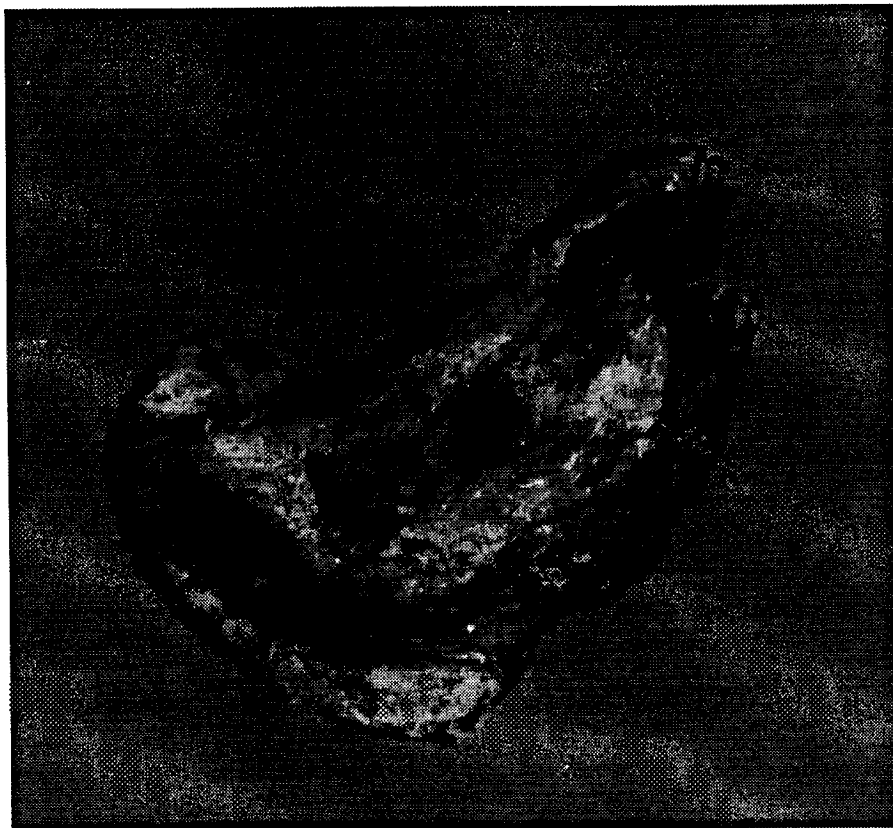
The largest particle found within the fiber weaves by inspection was a piece of polypropylene (see figures 3.2-12 and 3.2-13) which was 4.97 m from the failed end (anomaly #23A). The particle was approximately 0.8 mm in length and 0.4 mm in width.

Figure 3.2-12 — Contaminant Particle in Tether

Figure 3.2-13 — Polypropylene Particle

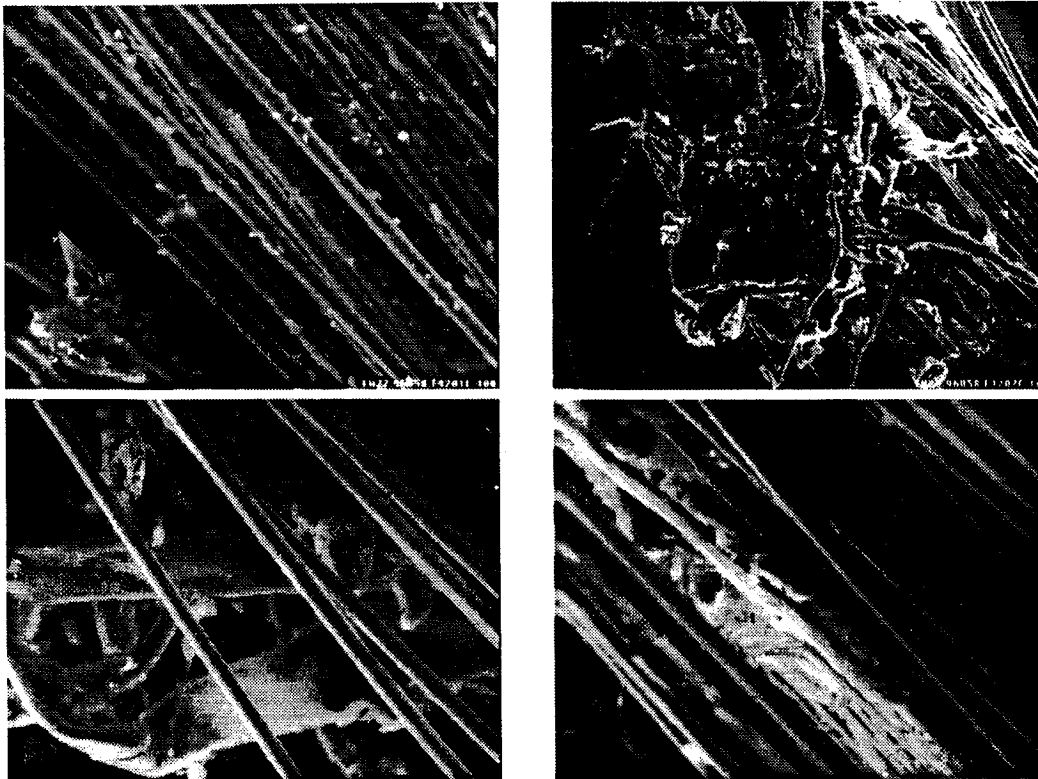
Figure 3.2-14 — R5 Kevlar 1 Analysis Areas

Other contaminants were found in the weave at several locations. As an example, at 11.73 m from the failed end (anomaly R5) a contaminated area was found (see figure 3.2-14). The contaminants included a particle approximately 0.4 mm in size (in upper right view of figure 3.2-14), as well as, a microscopic metal particle (in lower left view of figure 3.2-14). The EDS analysis on the first particle indicates that it is an accumulation of dirt (figure 3.2-15a), and the metal piece, (figure 3.2-15b) was identified as aluminum. The elemental constituency of contaminants found in different layers of the tether at other locations included: silicon, zinc, iron, calcium, chlorine, aluminum, and potassium. These were generally in low concentrations.

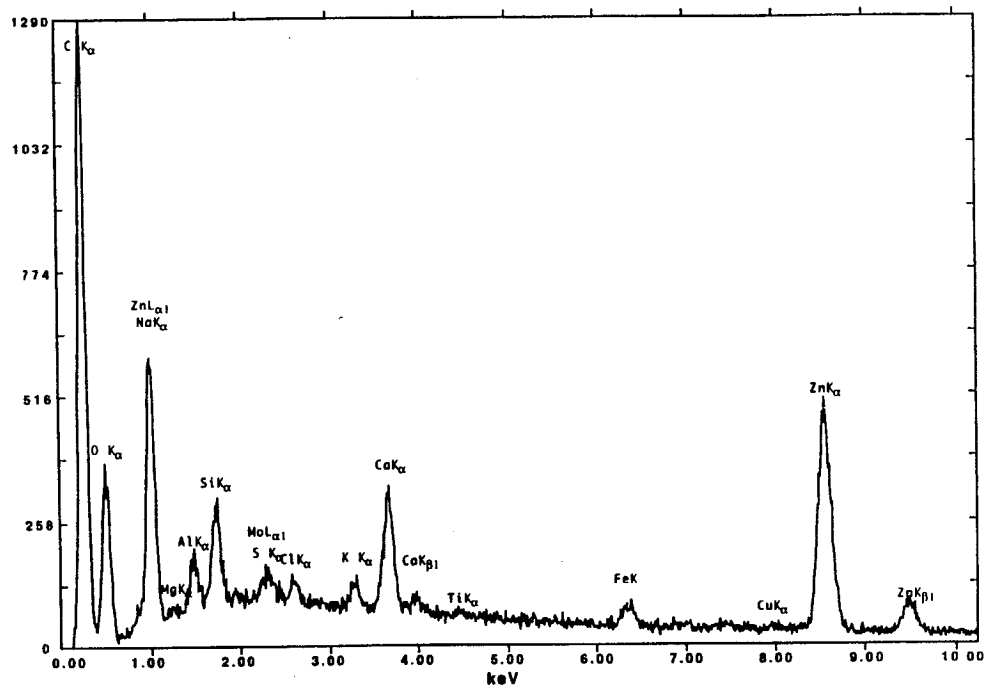
Figure 3.2-15a — EDS Analysis of R5 Kevlar 1 (dirt contaminant)

R5 KEVLAR 1  
 LAHGE MASS ON FIBERS (E4202) #1  
 Analyst: COSTON keV: 25.00 Current: 0.00 Live Time: 100.00 eV/Channel= 10.00  
 Detector Resolution: 148.50 eV Take-off angle= 40.00

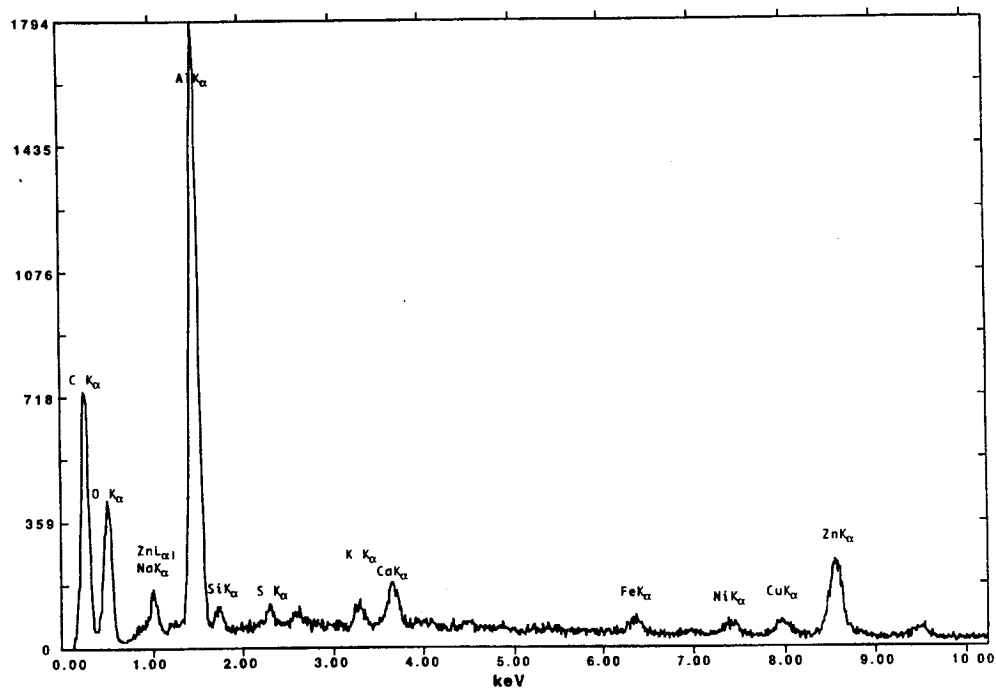
Figure 3.2-15b — EDS Analysis of R5 Kevlar 1 (aluminum trace)

R5 KEVLAR 1  
 RIBBON (E4204) #1  
 Analyst: COSTON keV: 25.00 Current: 0.00 Live Time: 100.00 eV/Channel= 10.00  
 Detector Resolution: 148.50 eV Take-off angle= 40.00

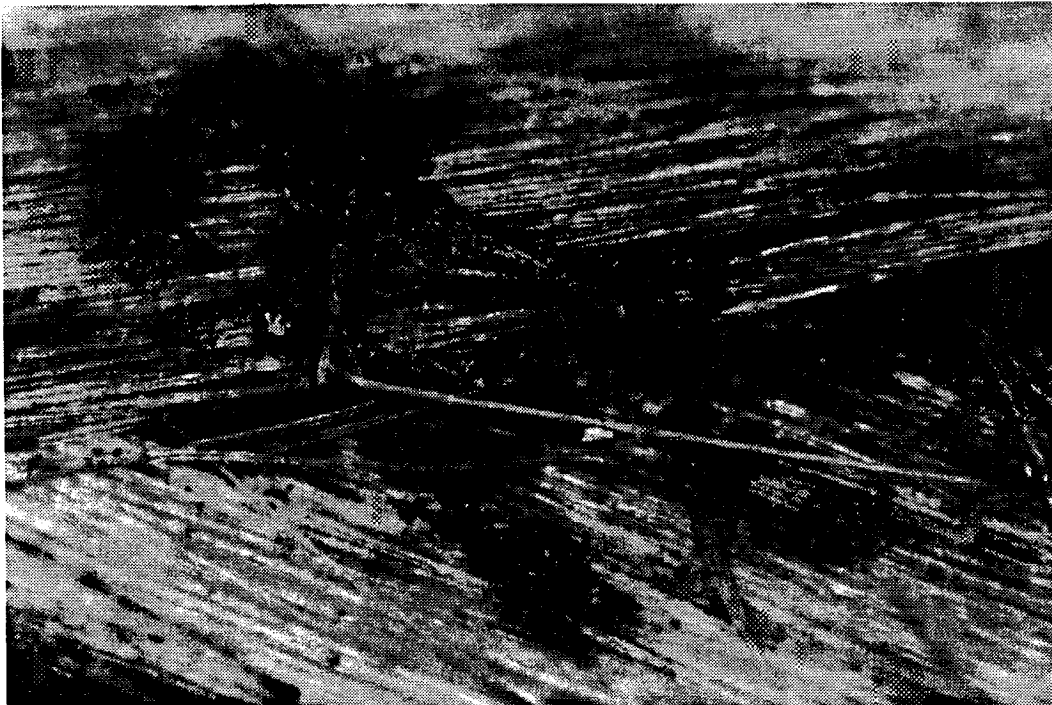
Figure 3.2-16 — Blue/Black Streaks

e) Blue/black streaks composed of some material in the Kevlar/Nomex fibers were found between the failed tether end and 13.67 m from that end (figure 3.2-16). No further streaking was found past the 13.67 m point. Heating of a length of tether or heating a local spot on the tether did not duplicate the blue/black streaks. This phenomenon is not completely understood, but is a post-failure mechanism, and did not contribute to the failure.

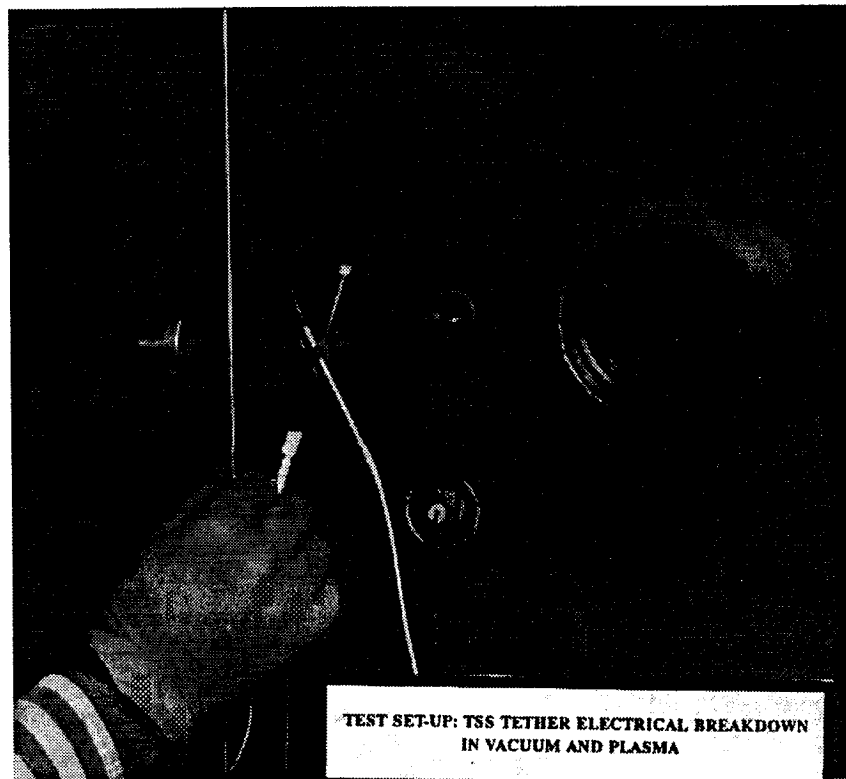
Figure 3.2-18 — Voltage Breakdown Test Setup

Grounded pointed end pushed through FEP; -3500 VDC; variable pressure; tension at 15 lb.

Arcing started at  $5 \times 10^{-3}$  Torr; tether broke in 6 sec.

In summary, the voltage breakdown tests reveal that a tether with undamaged FEP insulation will not break down (flow significant current) even for very high voltage conditions and ground planes in close proximity. Breakdown readily occurred when there was a thin cut or hole (breach) through the FEP to the copper wire conductor. When there was an insulation breach, the breakdown voltage ranged from approximately -2 kVDC to -4.5 kVDC, depending on the hole size and distance from the ground plane.

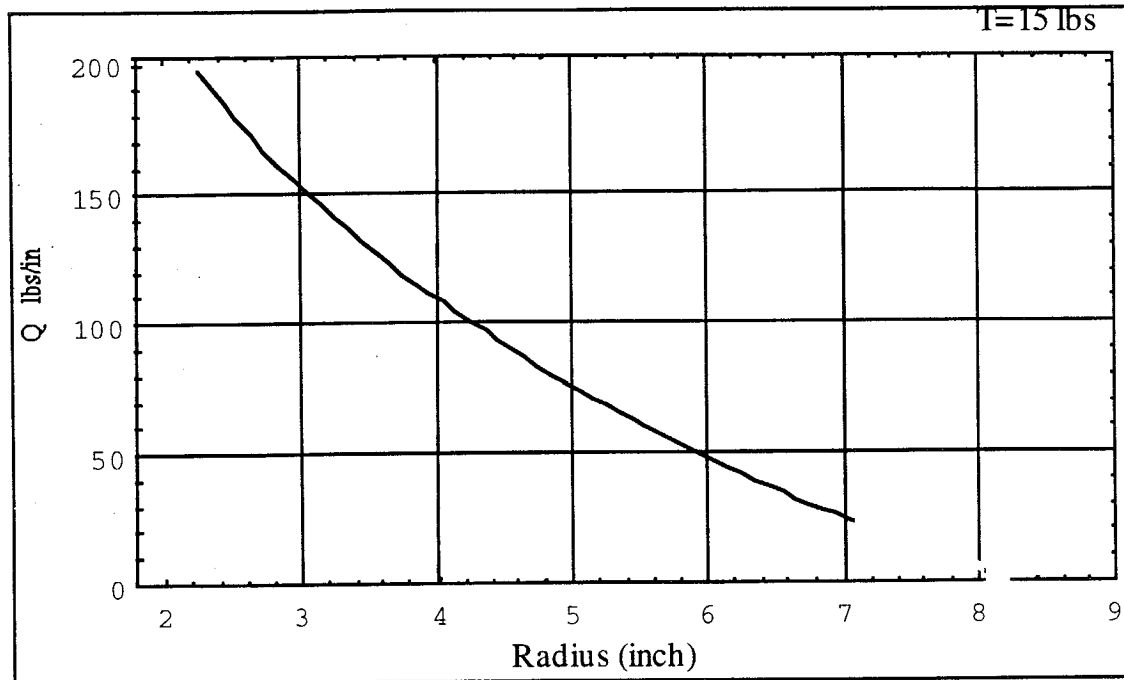
Figure 3.2-23 — Load per Unit Tether Length vs Reel Radius

It is apparent that the deeper in the wrap (i.e. smaller radius) the higher the compression load due to the wrap. At the location where the failed section of tether was stored, (i.e.  $R=2.25$  in.), the load due to wrapping is:

$$Q_{R=2.25} = 197.3 \text{ lbs / in} \quad \text{or} \quad Q_{R=2.25} = 345.5 \text{ N / cm}$$

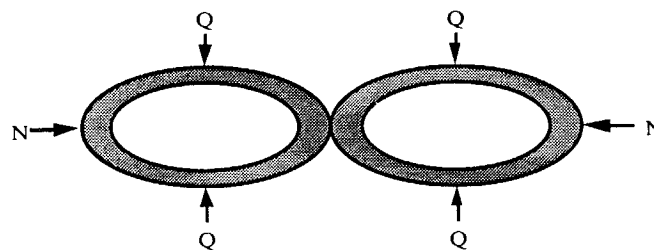
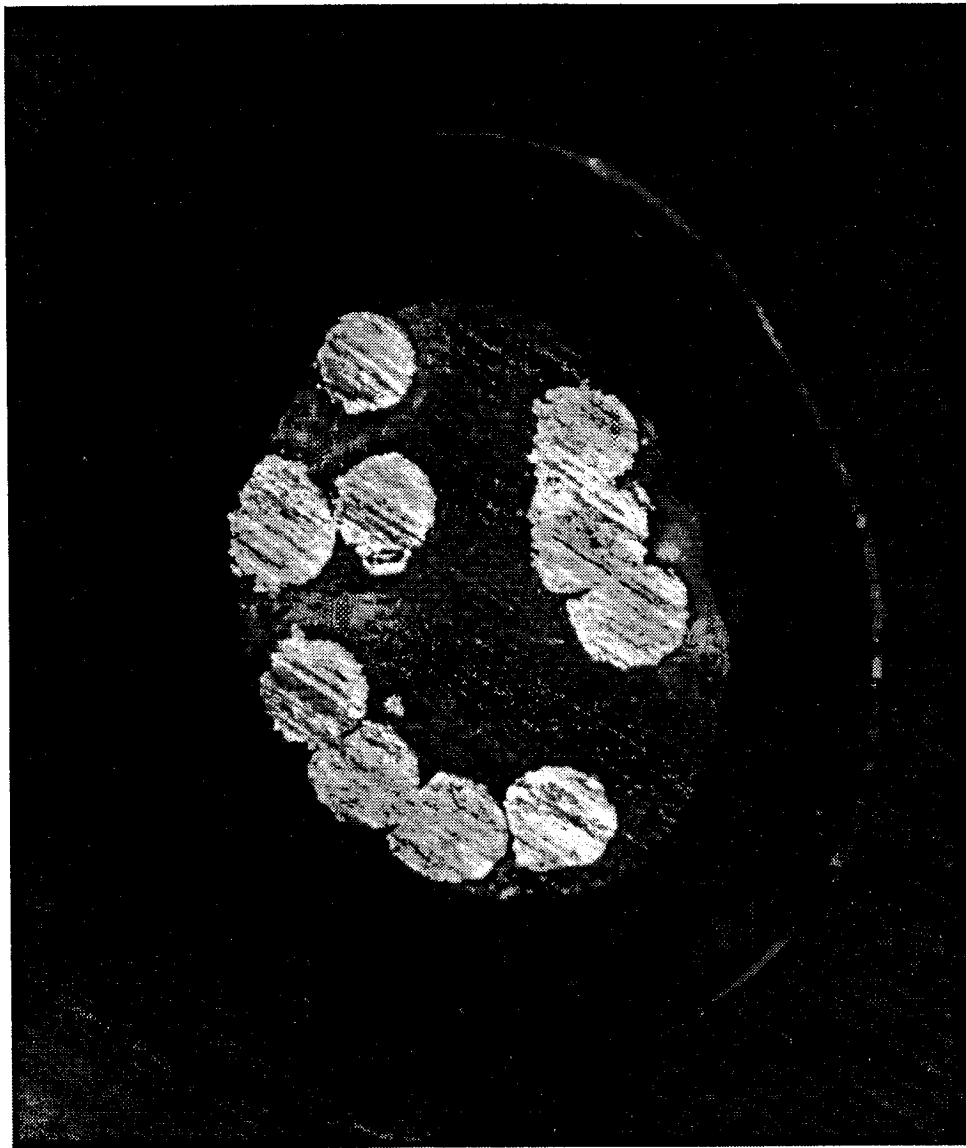
The result of this load would be to flatten (see figure 3.2-24a and figure 3-24b) the cross section (make oval) but, more importantly, it would tend to force any debris into the tether, especially, if it were present at the Kevlar FEP interface. This very high load is later reduced somewhat due to cold flow and copper flattening. But by then, debris present would have already been pushed into the FEP insulation.

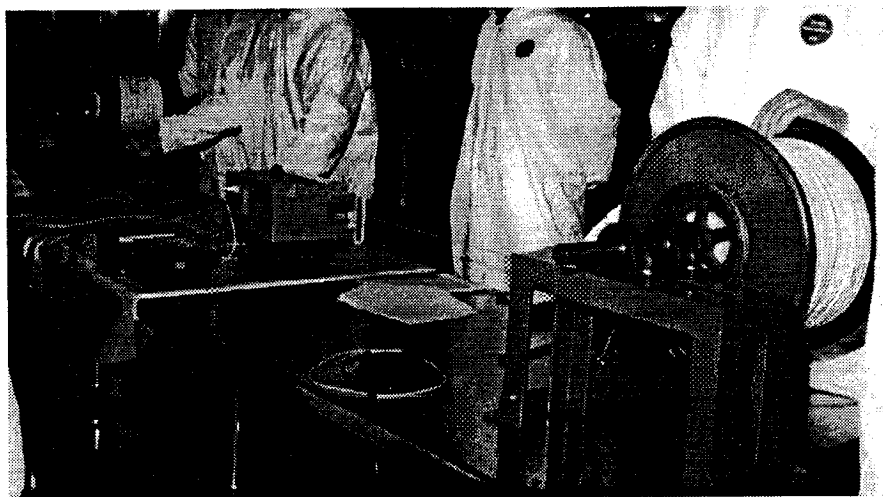
Figure 3.2-25 — Spark Test Set-up

The spark tests revealed each flaw (artificially induced) even the closed slit was detected easily. The entire 1989 m was spark tested using this very sensitive test setup. No breaches in the FEP insulation were found.

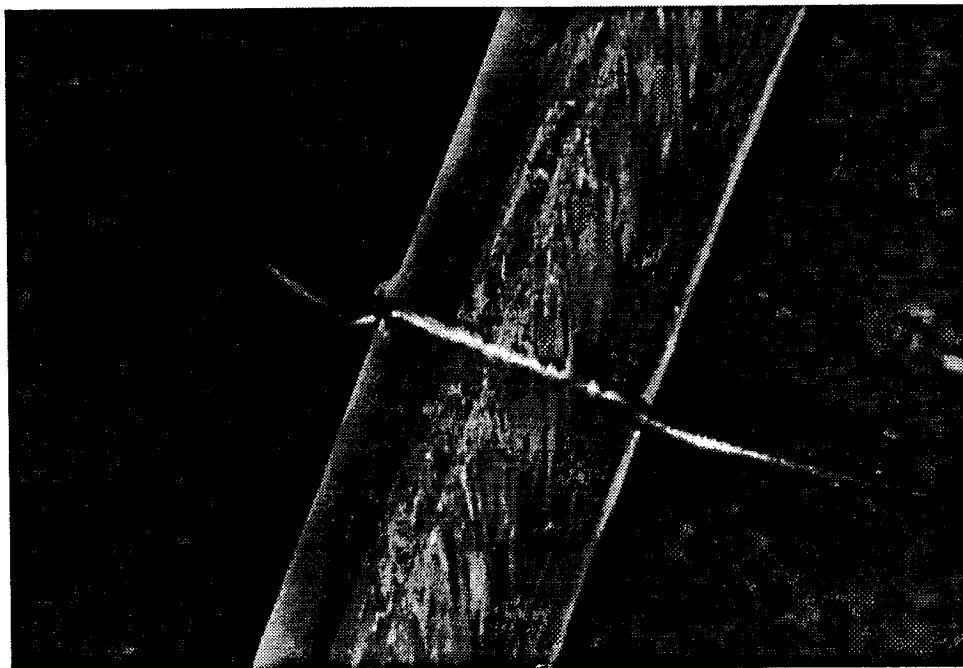
Figure 3.2-27 — Test to Determine the Ease of FEP Penetration

To establish the relative ease with which a small piece of debris can be made to penetrate the FEP insulation a qualitative test was performed. A small piece of #34 (.16 mm/.0063 in) wire, serving as debris, was pushed against FEP insulation and held. The wire did not penetrate at first but, after holding the force for a short time the, FEP parted and allowed the wire to penetrate. The result of this test can be seen in figure 3.2-27. A confirmation and further approximate quantification of those initial result is shown in figure 3.2-28

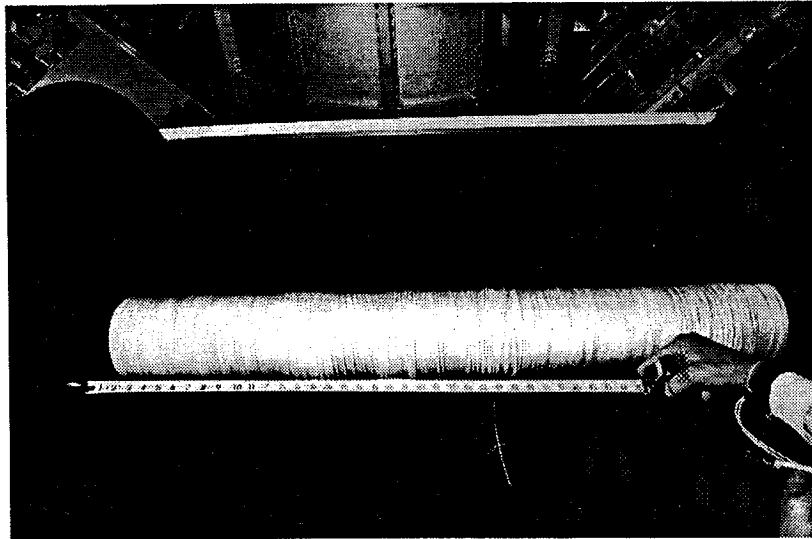
Figure 3.3-1 - Reel Assembly

The reel mechanism operated normally during the mission and did not contribute to the failure. Small metallic debris were found in the reel housing which could contribute to foreign object damage to the tether.

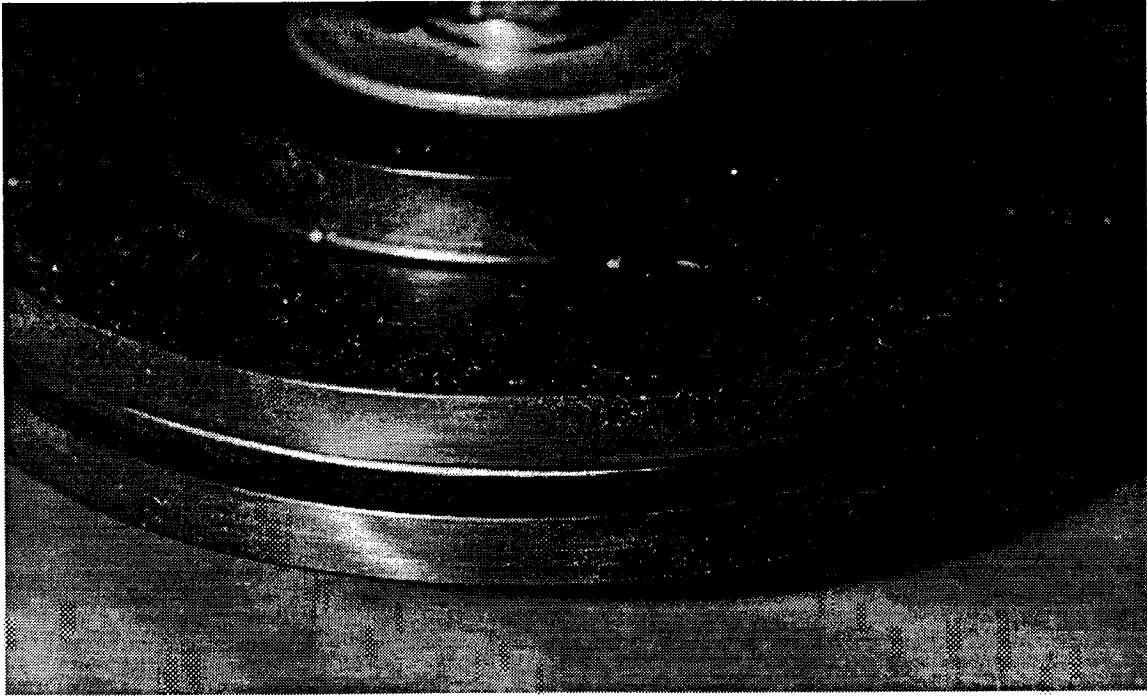
Figure 3.3-3 - LTCM First Idler Pulley

The interior of the LTCM contained a significant amount of debris (figure 3.3-10). The majority of the debris was non-metallic and consisted of shedded Nomex fibers from the tether. The metallic debris (up to 1 mm size) were analyzed and the images are presented in figures 3.3-11 and 3.3-12. EDS analysis identified most of the metallic particles as aluminum; a nickel particle

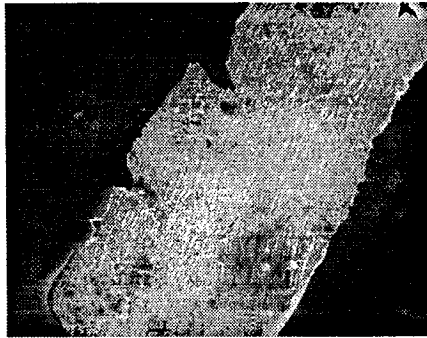
Figure 3.3-12 - SEM image of LTCM Metallic Debris (~1mm Size)

In addition to the contamination found within the tether, debris was found in several locations within the deployer mechanism. Metallic debris, large enough to breach the FEP, was found in the LTCM, the deployer boom assembly, and the reel housing. In the LTCM, a small piece of very fine silver plated wire, aluminum shavings, and unidentified non-metallic debris was found. Small metallic shavings were found attached to the back of small screw holes in the boom assembly.
